Space Shuttle Stiffener Ring Foam Failure Analysis, a Non-conventional Approach.

Philip M. Howard

NASA

Materials Science Division

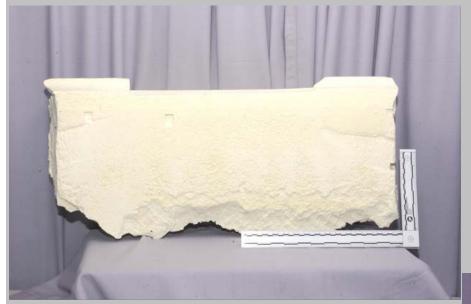
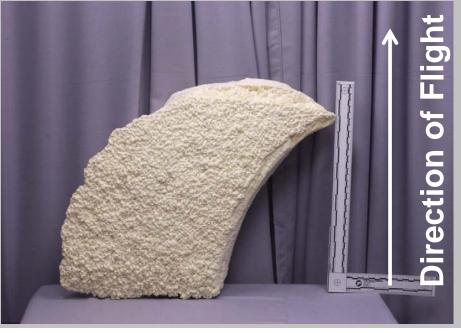
Solid Rocket Booster Stiffener Ring Foam Failure

The classical methods of analysis failed to provide a root cause into this foam failures for the 25 years.

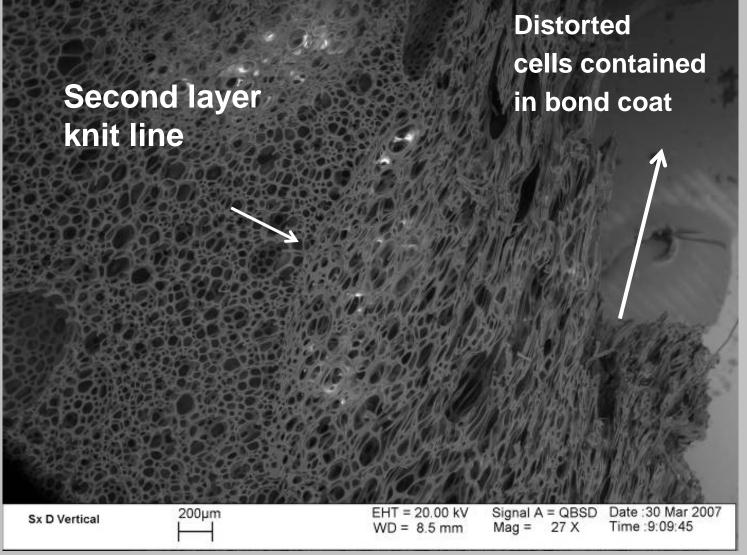
Cross Section of SRB Foam Failure

Chief SRB Engineer -we have never looked at foam like this

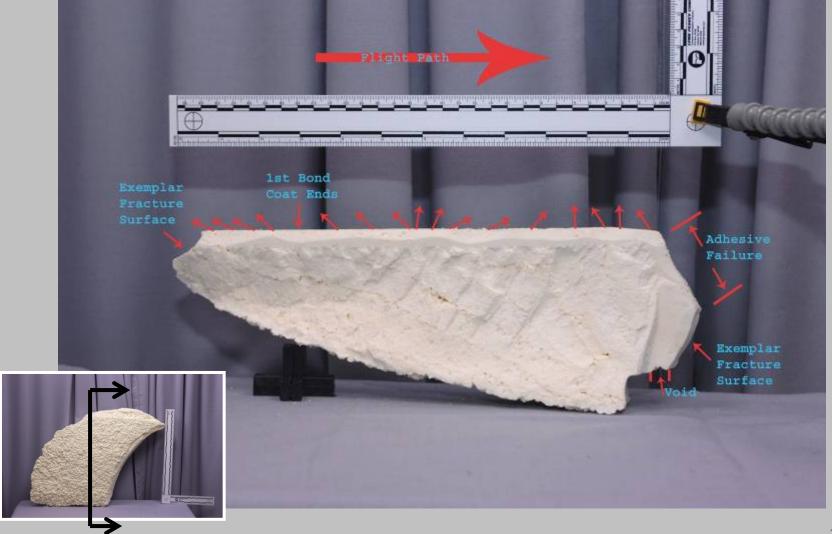
SRB Foam Failure

>80 percent application failed

The foam bond coat displayed two modes of failure:

- Cohesive failure was observed due to severely deformed foam cells in the bond coat
- Adhesive failure was observed at the RT-455 Epoxy interface.

The observed morphology indicates that the bond coat was not fully cured before other forces were applied, e.g. the expansion forces of the second coat distorted the bonding cells.

- Substrate as an infinite heat sink
- Develop spray hardware to apply micro bond layers << 1/8" layers
- Primer (polyurethane)
- The bond coat should be allowed to completely dry/cure
 - Never apply over wet uncured layers
